Intel[®] Mobile Celeron[™] Processor at 466 MHz, 433 MHz, 400 MHz, 366 MHz, 333 MHz, 300 MHz, and 266 MHz Specification Update

Release Date: April 2000

Order Number: 244444-014

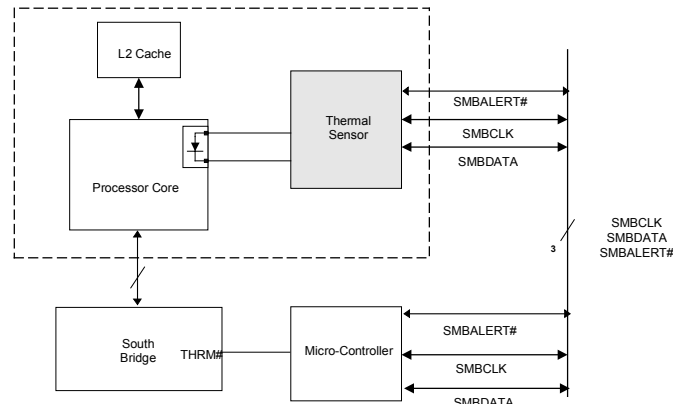
Figure 1. An Example of Microcontroller Driven Thermal Management

Problem: The Intel Celeron Processor Mobile Module has a thermal sensor that monitors the processor core's temperature. Please note that desktop systems could have a similar thermal device. The thermal sensor asserts SMBALERT# if the processor temperature exceeds the temperature limits set in the Alarm Threshold Registers (T_{HIGH} , T_{LOW}). It also sets the corresponding Status Register bits to identify the cause of the interrupt. Figure 1 gives one example of the how the SMBALERT# signal could be used in a system.

Implication: There is no system impact from this erratum if temperature polling is used for processor thermal management. If the SMBALERT# interrupt is employed to manage processor thermal sensing, then servicing the false interrupt may result in premature system action depending on the software and hardware implementations used. The rate of the false interrupts is less than the auto-convert rate of the thermal sensor.

Workaround: Three different (mutually exclusive) workarounds are possible:

1. Before servicing an interrupt from the thermal sensor, read and compare the processor thermal reading with the threshold limits (T_{HIGH} or T_{LOW}). Figures 2 and 3 provide basic flowcharts for the implementation of this workaround in an interrupt driven system.
2. If the firmware implemented polls the Status Register only, then before taking any action, re-read the temperature register and do a comparison with the alarm threshold limits (T_{HIGH} or T_{LOW}) to determine if the value is actually still within the temperature window.
3. Use a temperature polling scheme to monitor the processor temperature.
